Spindle Lubrication Discovery on No. 2 RCM at Nucor Steel-Berkeley

Presented at the
**Iron & Steel Technology
Conference**
August, 2006

*Jason R Curtis, Meltshop Maintenance Supervisor, Nucor Steel-Berkeley;
Joseph A. Downie, Vice President, Surface Engineering Associates and
Martin J. Brown, Chief Engineer, Mill Products, Ameridrives Couplings*

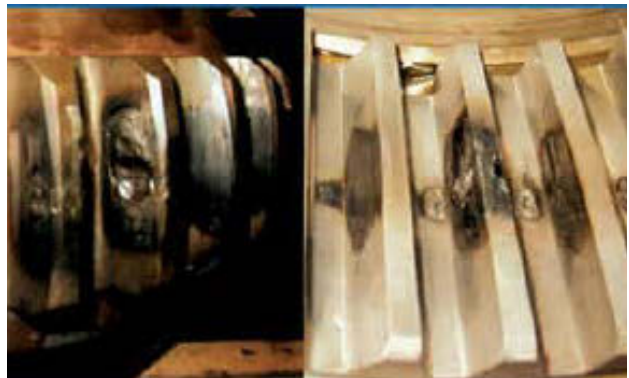
Figure 3

Gear hub and gear ring after synthetic oil trial.

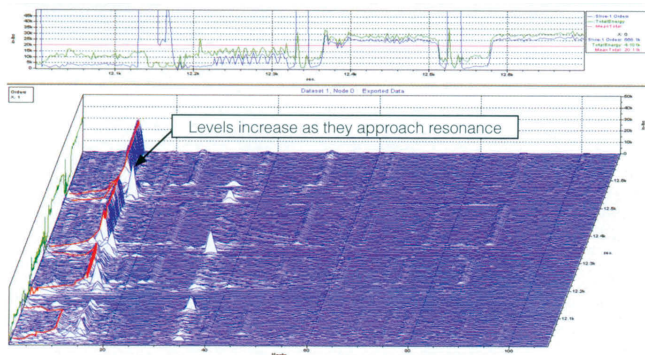
Figure 6

Resonance frequency.

The most extreme load split observed was 42% of the load on the top spindle with 58% of the load on the top spindle (Figure 5). The most disturbing evidence was the discovery of torsional resonance at a frequency that was common based on run conditions (Figure 6).

After reviewing the IVC data, it was determined that the peak torque was within design parameters and the load splits were within common parameters of the mill design, but the torsional resonance should be a concern. Nucor Steel-Berkeley agreed to investigate U-joints based on the successful conversion of the No. 1 RCM from gear spindles to U-joints.
