# Spindle Lubrication Discovery on No. 2 RCM at Nucor Steel-Berkeley

Presented at the  
**Iron & Steel Technology  
Conference**  
August, 2006

*Jason R Curtis, Meltshop Maintenance Supervisor, Nucor Steel-Berkeley;  
Joseph A. Downie, Vice President, Surface Engineering Associates and  
Martin J. Brown, Chief Engineer, Mill Products, Ameridrives Couplings*

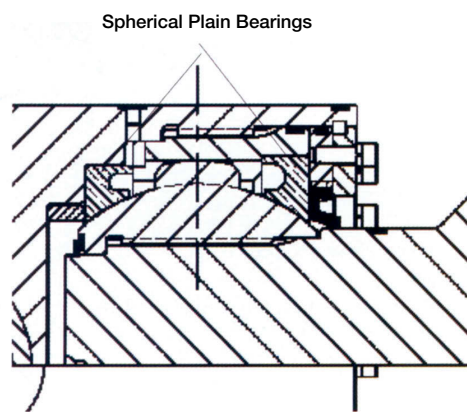
Figure 1

Typical gear arrangement at each end

The mill began operation on April 26, 2001. The spindle design had some unique design features due to the axial work roll shifting feature (Figure 1), in that it required a spherical plain bearing on each side of the gear hub to keep the gear ring centered on the gear hub.

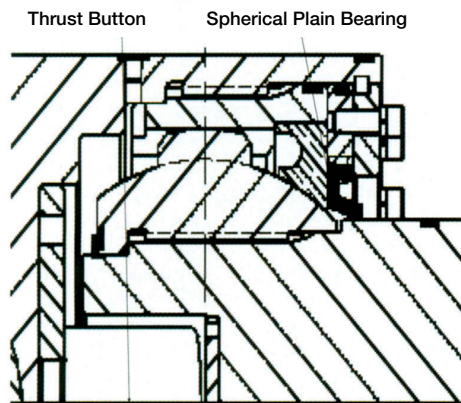
Figure 2

Gear assemblies with thrust button.

It was still believed that the spherical plain bearings were a problem. Ameridrive's recommendation was to removed one of the spherical plain bearings in each assembly and replace the bearings with a thrust button arrangement (Figure 2). In order to get rid of the second spherical plain bearing, a spring pack would need to be installed in the splined, or center, section of the spindle to keep the thrust buttons seated and to keep the gear assemblies centered. There were concerns with "spring loading" the spindle as a result of the axial forces that would be transmitted to the pinion stand gear assembly, due to the triple-shaft double-helical design of the pinion stand. The spring pack option was decided against because of the risk of pinion stand gear assembly damage.

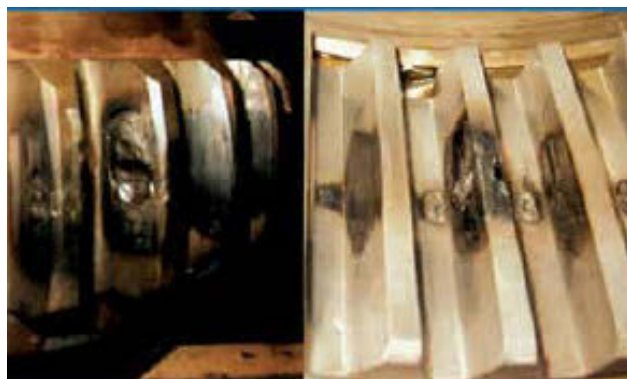
Figure 3

Gear hub and gear ring after synthetic oil trial.

The oil that was chosen has a viscosity of 46,000 cSt at 40°C, 1,250 cSt at 100°C or roughly 230,000–6,000 SUS and was supplied by a major oil company. The trail was installed on Dec. 26, 2003. The water was removed, and the mill loads were increased to 100%. Temperatures were very good initially, but started to elevate after running for two weeks. The cooling water was turned back on, and the mill load was reduced back to 80%. The gearset failed after one month of operation (Figure 3). The seals again became a topic of discussion due to the lack of oil remaining in the assemblies when they were removed.

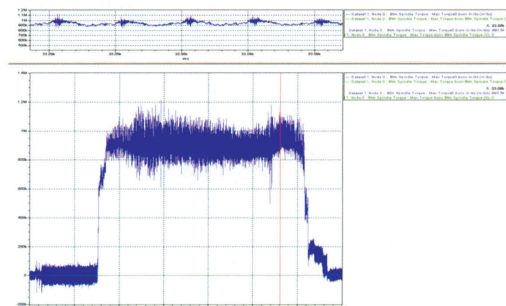
Figure 4

Trend showing maximum torque on bottom spindle.

any vibration conditions. The mill load was returned to 100% for the tests. The spindle was designed for 1,225,200 in-lbs. of torque. The highest level of torque seen during the testing was approximately 1,000,000 in-lbs. (Figure 4).

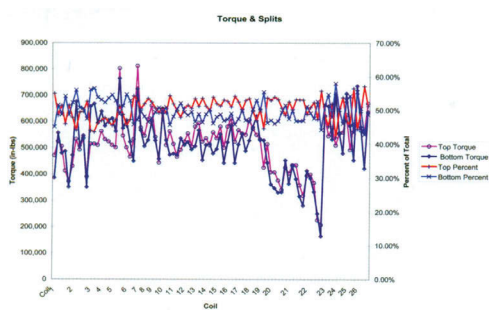
Figure 5

Maximum load splits per coil.

The most extreme load split observed was 42% of the load on the top spindle with 58% of the load on the top spindle (Figure 5). The most disturbing evidence was the discovery of torsional resonance at a frequency that was common based on run conditions (Figure 6).

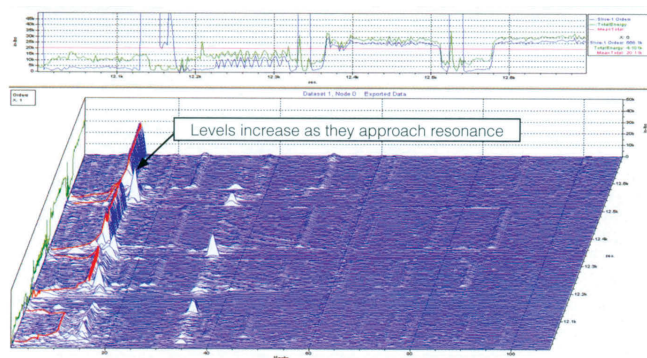
Figure 6

Resonance frequency.

After reviewing the IVC data, it was determined that the peak torque was within design parameters and the load splits were within common parameters of the mill design, but the torsional resonance should be a concern. Nucor Steel-Berkeley agreed to investigate U-joints based on the successful conversion of the No. 1 RCM from gear spindles to U-joints.

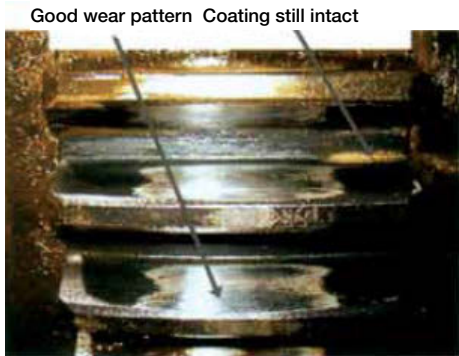
Figure 7

Teflon-coated gear hub.

In the meantime, a trail was chosen to apply a Teflon coating on the teeth of both the gear hub and gear ring in cooperation with Surface Engineering Associates (SEA). The Teflon lubricity properties were discovered by accident when used in a different application. The spindle with the Teflon-coated gearing was installed in April 2004 with no cooling water and 100% mill load. The temperature elevated within a few shifts, which seemed strange due to the lack of spalling witnessed at disassembly (Figure 7). The cooling water was turned back on and the mill load reduced to 80%, and the spindle was removed after two months for another trial.

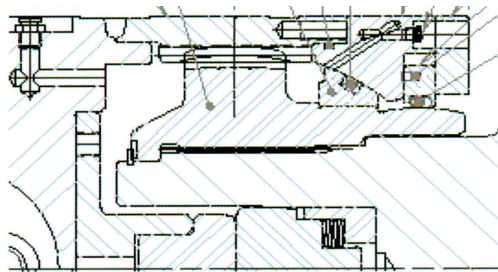
Figure 8

Trial roll-end gear assembly.

In May 2005, Nucor Steel-Berkeley decided that it was appropriate to begin discussions with other gear spindle companies while maintaining open lines of communications and trials with Ameridrives. During the discussions with other companies, the topic of the flow or “pumping” action of the grease at the gear mesh came up again. Nucor was asked to check the angle of the spindles at the static (roll change) position and dynamic (run) position. The results were eye-opening. At the static position, the spindles were at 0.9°. In the run condition, a 0.6° offset was measured with the largest work roll diameter, while there was only a 0.4° offset with the minimum-diameter work rolls. These parameters were four to five times less than what the original spindle was designed around. Nucor selected two companies to build a spindle, with one company’s design on the roll end and the other company’s design on the drive end – a hybrid spindle. The roll-end design company proposed a new gear assembly, making changes to the tooth profile geometry, the sealing arrangement, and the heat treating of the teeth to carburized and ground (Figure 8). The drive-

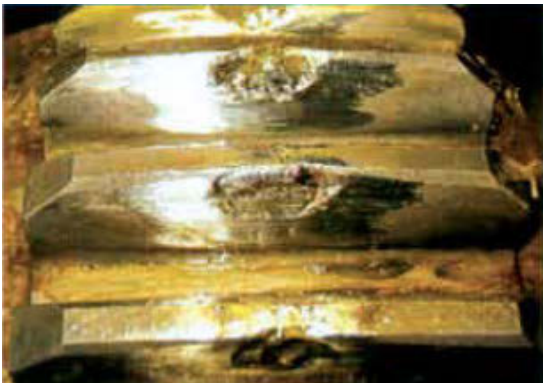
Figure 9

Gear hub after Lyon additive blended with grease.

would not be able to contain it alone. On Jan. 10, 2005, the two greases were mixed on-site and purged through both gear sets of the bottom spindle. The cooling water was shut off and the mill load was returned to 100%. The results were the best to date from a temperature standpoint. The temperatures were very low on both ends for approximately one week before they began to elevate. However, temperatures continued to elevate, so the spindle was removed (Figure 9). Due to the promising initial results with the two different oils that had been experimented with, Nucor and Ameridrives decided to aggressively pursue an alternative seal design in this application. Ameridrives had just finished testing a "boot seal" in another

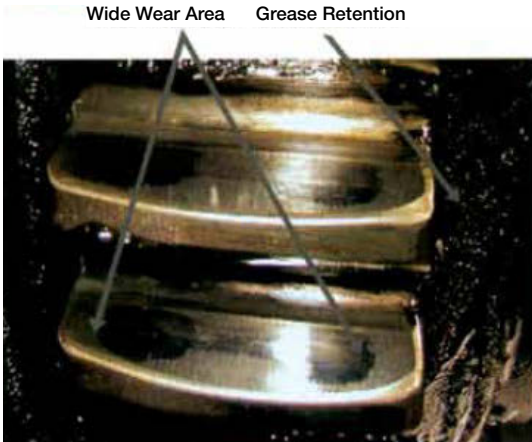
Figure 10

Results of tooth profile changes on roll end of hybrid spindle

The "hybrid" spindle was installed on Feb. 1, 2005. The drive end quickly overheated, and the cooling water was resumed, but the mill load was left at 100%. On March 24, 2005, the drive end of the hybrid spindle failed, so the mill load was reduced to 80% and a normal spindle was installed. While the spindle was out, the roll-end gearing of the hybrid spindle was inspected and looked to be in good condition (Figure 10). It appears that the tooth profile change had succeeded as indicated by using more surface area of the tooth and spreading out the load.

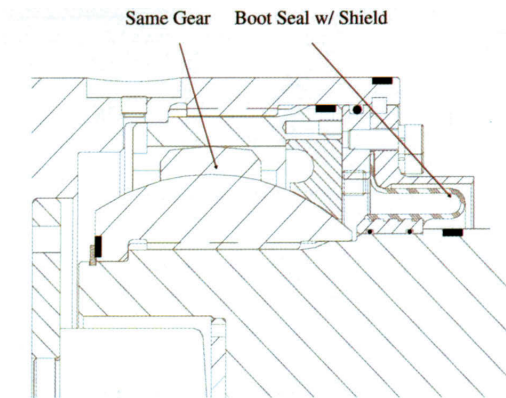
Figure 11

Boot seal with shield.

On July 1, 2005, the boot seal spindle (Figure 11) was installed. The spindle employs the same gear design, magnetic plugs in the fill ports to collect wear particles, and of course the boot seal. The mill was put back to 100%

Ameridrives, having had recent experience with boot seals, had determined that they were a positive sealing method with the capability for compensating for angular misalignment. While boot seals can tolerate some axial length changes, they cannot be pressurized. Boot seals for this application were determined to be uniquely suited.

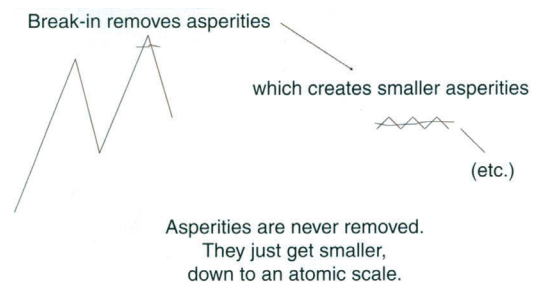
Figure 12

The fractal nature of surface wear.

The fractal nature of surface wear is illustrated in Figure 12. It is seen that continued magnification does not really change the asperity shape very much, it just gets smaller. Hydrodynamics lubrication hopes to get fluid in the valleys, which creates a pressure to lift the surfaces apart, creating a boundary film. The Lyon technology provides a film that sticks to both the peaks and valleys. This polar bonding mechanism is independent of viscosity, so even if there is a hydrodynamic "lift," the asperities still carry

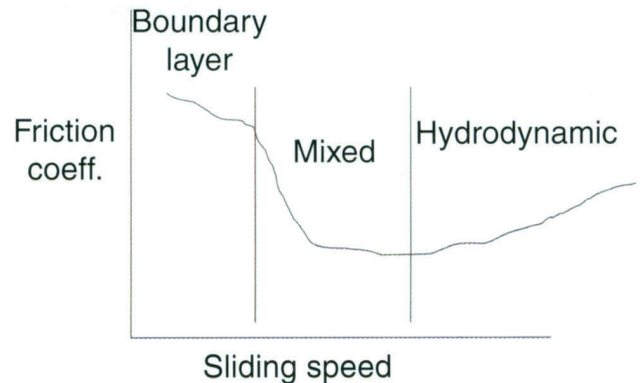
Figure 13

Stribeck curve.

The Stribeck curve (Figure 13) is commonly used to show the transition from full lubrication, or hydrodynamic state, through mixed lube, and finally into the boundary lubrication condition. Mathematically, this condition can be predicted by the lambda ratio, which compares combined roughness of the two surfaces to the lube film that separates them. This calculation is an approximation because the surface characteristics are an average. Also, the lube film thickness says nothing about the other properties of the lube.

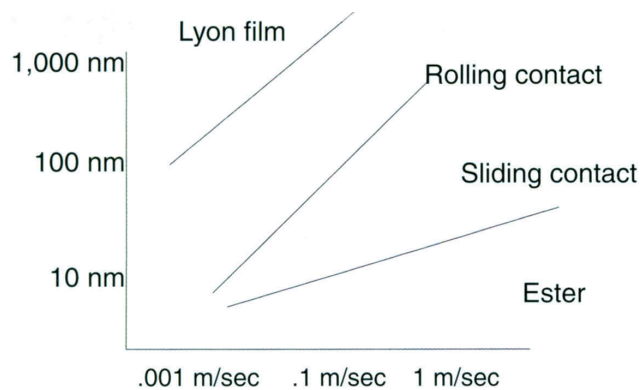
Film thickness versus rolling speed.

Figure 14 gives an idea of how squeeze film thickness changes with speed. This test was done at about 150,000 psi with surface finishes on the order of 10 nm. With sliding contact, much rougher surfaces and higher contact stress, the conditions in the spindle were much more severe.

The thickness of the Lyon boundary layer film is superimposed on Figure 14, along with a representation of how the film would be made thinner by sliding contact.

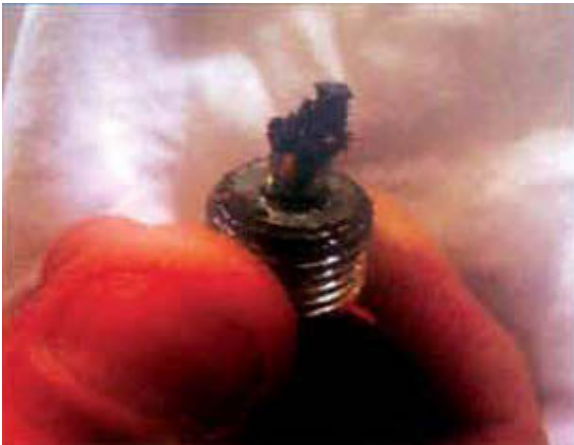
Figure 15

Magnetic plug with metallic shavings.

After approximately four hours of running, the mill was stopped to check the oil level in the pods. The level was good, but a lot of metallic shavings were seen on the magnetic plugs in the roll-end pod (Figure 15), but none were seen on the plugs for the drive end.

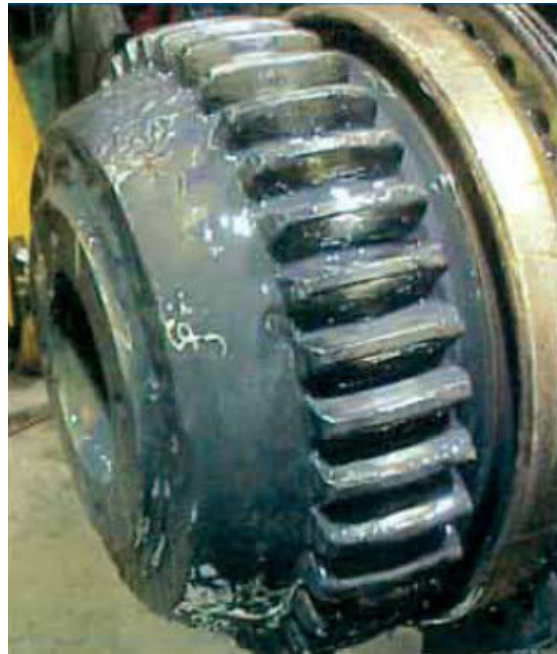
Figure 16

Gear hub dripping with oil.

The spindle was removed on Nov. 10, 2005, to install a U-joint spindle for trial. The results were exactly what was expected. The boot seals worked very well because both gear assemblies had plenty of lubricant (Figure 16). The roll-end gear hub was severely spalled (Figure 17), but it is believed that the damage happened early and did not progress once the lubricant was changed. The drive-end gear ring and hub (Figures 18-19) were in excellent condition. The contact area was polished, but there was no measurable wear. The results of the boot seal and Lyon oil combination were good and were considered a success.

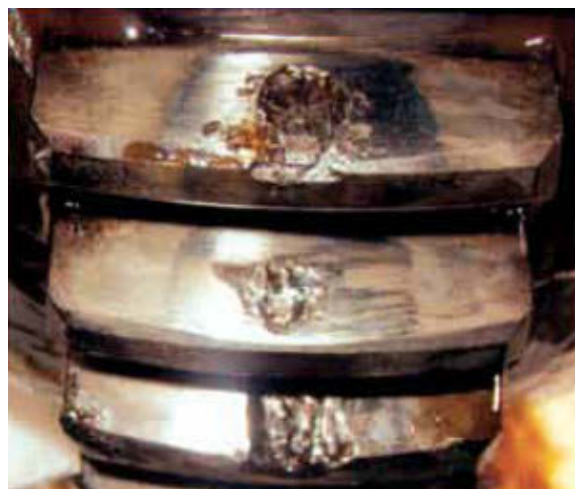
Figure 17

Gear hub with major oil company's product.

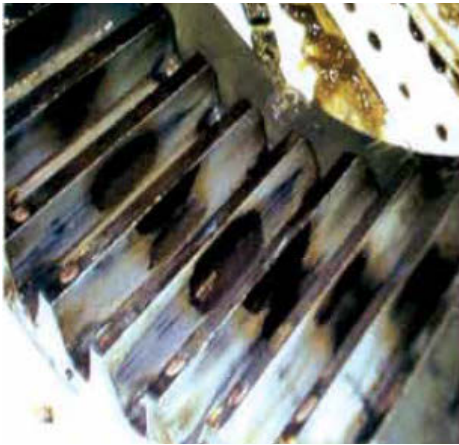
Figure 18

Gear ring on Lyon product.

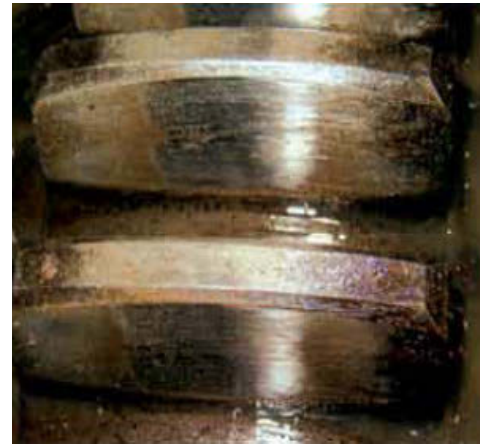
Figure 19

Gear hub on Lyon products
